Manhole Inspection Summary

Manhole # **S31C__020MH**

Insp Date: **10/17/07 4:35 PM**

Location Address: **411 GREENE ST**

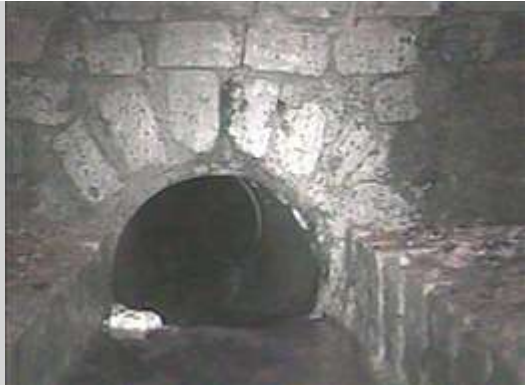
12 O'Clock Outflow

10 in. Circular Gravity Sewer
Pipe Out @ 12 O'Clock

Pipe Height: 6 (in.) Rod and Bar
Pipe Material: **Clay** ☐ Pipe Lined
Invert Depth: **13.13** (ft.) Flow Characteristics: **Slow**
Deposits: ☒ None ☐ Mud ☐ Sludge ☐ Debris ☐ Grease
Silt Depth: (in.) Deposits Extent:
Infiltration: **None** Pipe Seal Cond: **Sound**

Drop: **None**

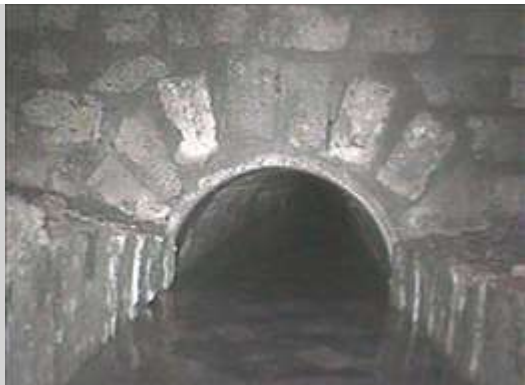
6 O'Clock Inflow

10 in. Circular Gravity Sewer
Pipe In @ 6 O'Clock

Pipe Height: (in.) Direct
Pipe Material: **Clay** ☐ Pipe Lined
Invert Depth: **13.08** (ft.) Flow Characteristics: **Slow**
Deposits: ☒ None ☐ Mud ☐ Sludge ☐ Debris ☐ Grease
Silt Depth: (in.) Deposits Extent:
Infiltration: **None** Pipe Seal Cond: **Sound**

Drop: **None**
